Navajo Abandoned Uranium Mine

Site Screen Report

NA-0917A AUM Site

Navajo AUM Northern Region

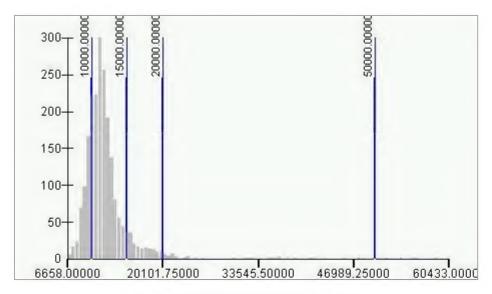
A total of 2,123 gamma radiation measurements were collected from the mine site, ranging from 6,658 cpm to 60,433 cpm. The measurements are represented in Figures 1 and 2.

Background Locations #1 9,604 cpm

Average background = 9,604 cpm
